AFFDL-TR-66-113

A FEASIBILITY STUDY FOR THE DEVELOPMENT OF A FATIGUE DAMAGE INDICATOR

LOCKHEED-GEORGIA COMPANY

JANUARY 1967

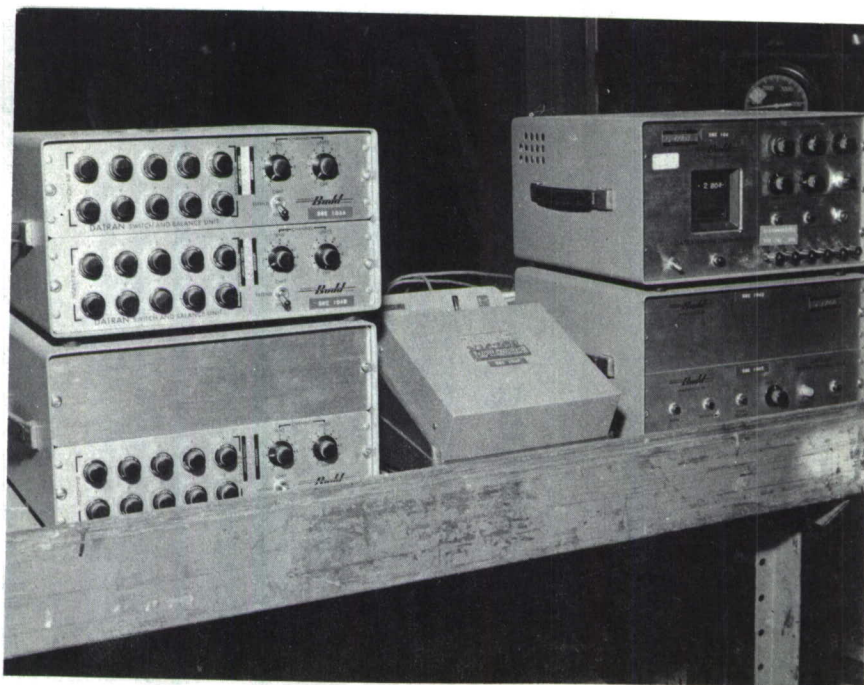
FIGURE 85 EQUIPMENT USED FOR RECORDING STRAIN
GAGE OUTPUTS DURING THE STRESS SURVEY
